Manhole Inspection Summary

Manhole # S39A2_004MH

Insp Date: **4/24/08 3:06 PM**

Location Address: **3901 5th St.**

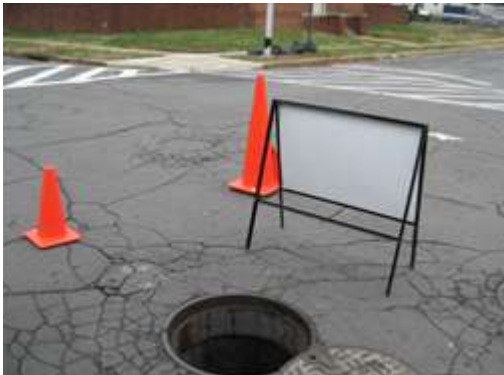
Location View

5th St & Jeffery St intersection

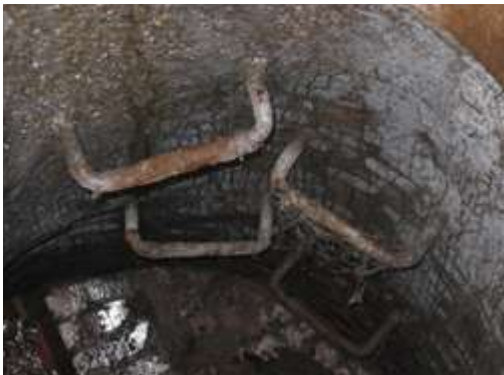
Count: **4** Missing: **0** ☒ **Corroded**

steps

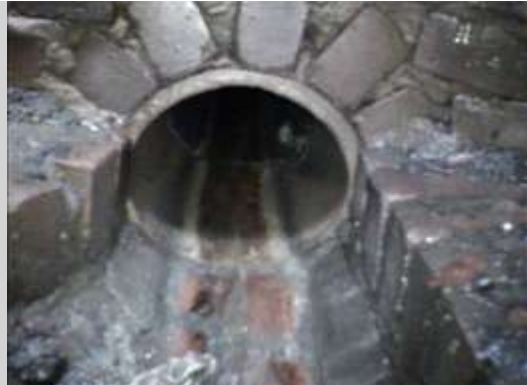
12 O'Clock Outflow

8 in. Circular Gravity Sewer
Pipe Out @ 12 O'Clock

Pipe Height: **8.4** (in.) Rod and Bar (Angled)
Pipe Material: **Clay** ☐ Pipe Lined
Invert Depth: **9.24** (ft.) Flow Characteristics: **Fast**
Deposits: ☒ None ☐ Mud ☐ Sludge ☐ Debris ☐ Grease
Silt Depth: (in.) Deposits Extent:
Infiltration: **None** Pipe Seal Cond: **Sound**

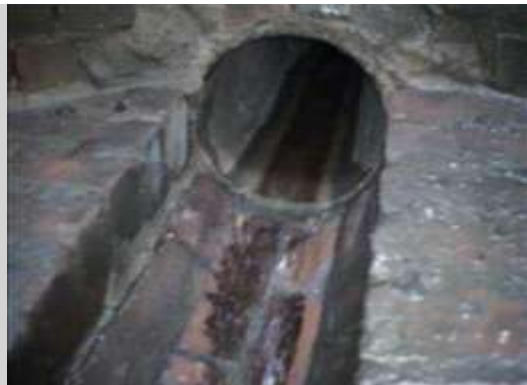
6 O'Clock Inflow

8 in. Circular Gravity Sewer
Pipe In @ 6 O'Clock

Pipe Height: **6** (in.) Rod and Bar (Angled)
Pipe Material: **Clay** ☐ Pipe Lined
Invert Depth: **8.72** (ft.) Flow Characteristics: **Fast**
Deposits: ☒ None ☐ Mud ☐ Sludge ☐ Debris ☐ Grease
Silt Depth: (in.) Deposits Extent:
Infiltration: **None** Pipe Seal Cond: **Sound**

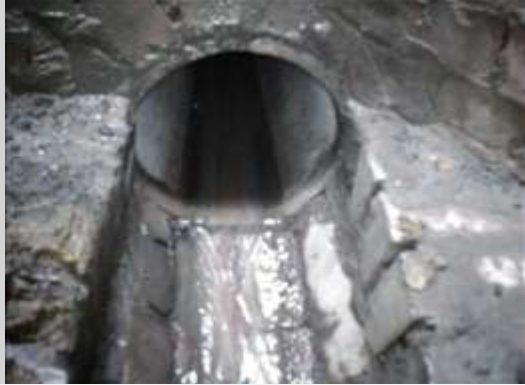
9 O'Clock Inflow

8 in. Circular Service Sewer
Pipe In @ 9 O'Clock

Pipe Height: **7.2** (in.) Rod and Bar (Angled)

Infiltration: **None** Pipe Seal Cond: **Sound**
